AIRCRAFT ACCIDENT REPORT

BRANIFF AIRWAYS, INC.

BAC 1-11, N1553

NEAR FALLS CITY, NEBRASKA

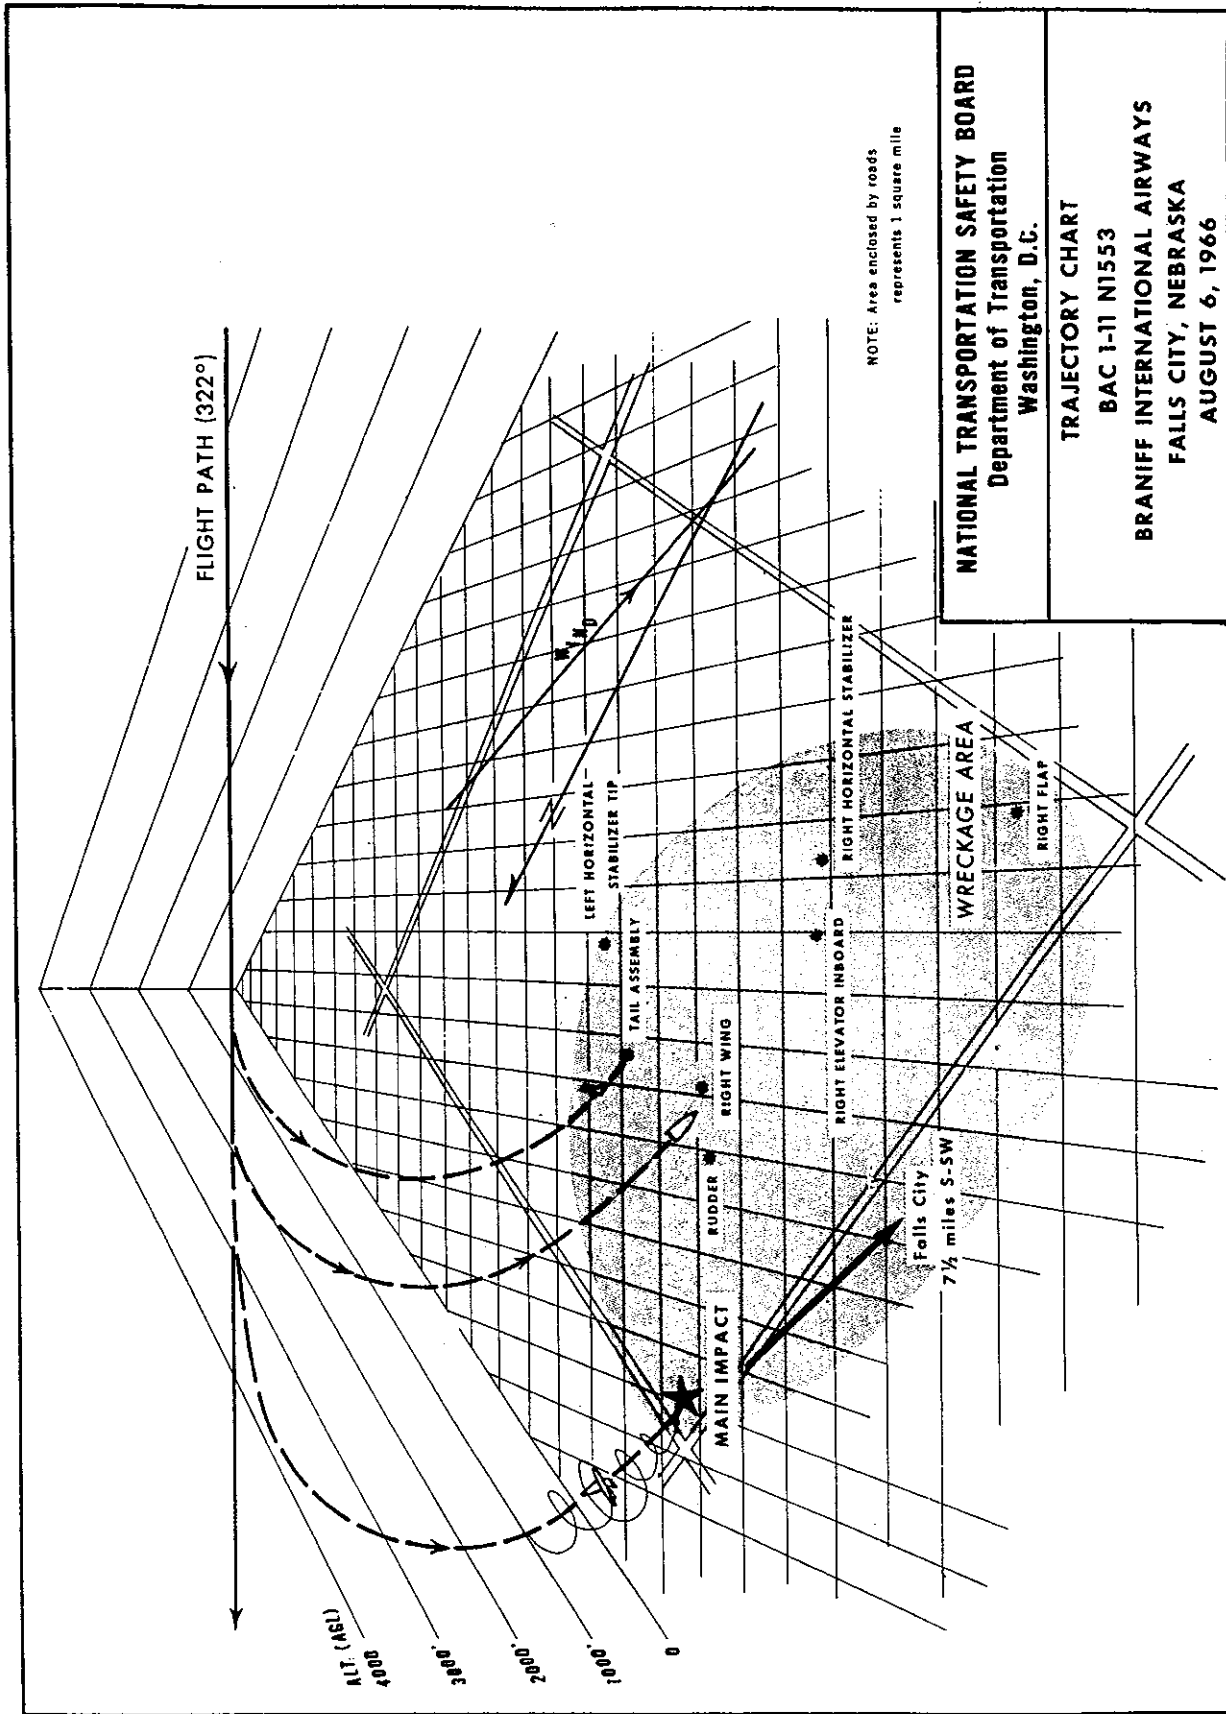
TRAJECTORY CHART
 BAC 1-11 N1553
 BRANIFF INTERNATIONAL AIRWAYS
 FALLS CITY, NEBRASKA
 AUGUST 6, 1966

the aircraft was heading approximately 110 degrees magnetic with the right wing low. There was no indication of any horizontal displacement after initial impact. Portions of the right wing and the empennage were not found at the impact site. The right wing had separated near Rib 11 and the outboard section was found at a true bearing and distance from the main impact site of 147 degrees/2,503 feet respectively. The separated portion of the vertical fin with the left tailplane and part of the right tailplane attached was found 131 degrees/2,752 feet from the site, while the piece of the right tailplane outboard of Rib 3 was located 159 degrees/4,375 feet from the site. These and all other major pieces of the aircraft were found within a one square mile area located to the south and east of the site. (See Appendix D, Trajectory Chart.)

the air of the falling objects and projecting these backward from the known locations on the ground. The intersection of the paths of common or associated objects is indicative of the likely point in the air where the part(s) separated from the aircraft. This approach, therefore, is useful in assessing the probable structural failure sequence. Work of this nature is certainly not an exact science since one must first make some basic assumptions which then have significant effect upon the accuracy of the final results. However, the trajectory analysis is considered a valuable tool which can be used to verify the results of other work or to point out possible avenues of research. Since Flight 250 was being tracked by USAF Air Defense Command radar reasonably accurate information regarding the track, ground speed and height above ground was known. The drag coefficients of the various falling parts and the mean velocity of the wind acting upon these parts have had to be estimated using the best available data. However, reasonable variations in these parameters did not affect the basic conclusions. Based upon a study of the separated components it was concluded that: (1) the breakup must have occurred within a very short time, perhaps in a time interval in the order of two seconds, and (2) the fin-tailplane combination probably separated before the wing.

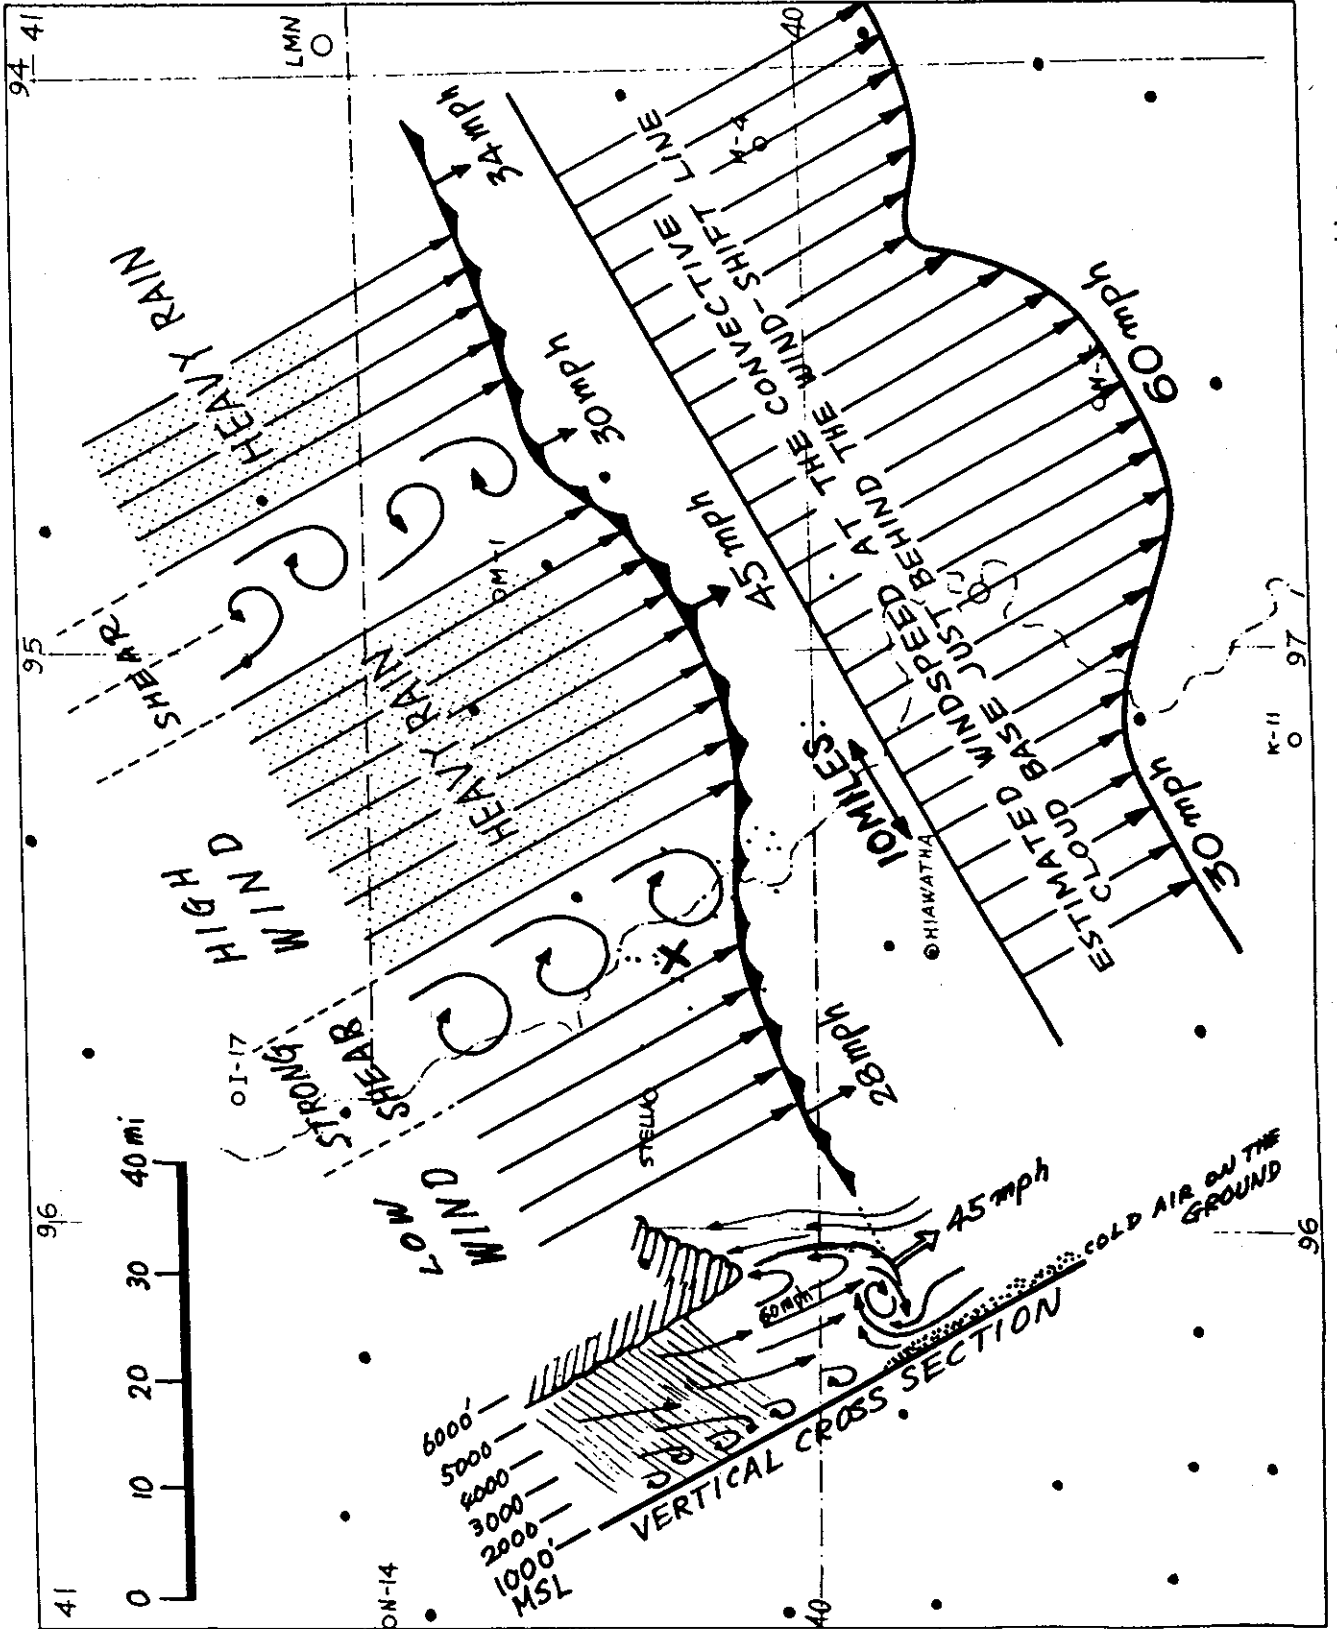
or its variation from one location to another, was unusually large. Specifically, the rainfall in an area located about 30 miles northeast of the accident site was observed to be over four times that to the west of the site. Therefore, the witness concluded that the rain-induced cold air mass to the east was about four times larger than that to the west of the site. The effect this variation has on the velocity of the wind-shift line and/or the first gust speed just behind that line is shown by Appendix F, Meteorological Schematical Diagram. It is noted that between these masses of air of different velocity there is a zone of strong horizontal wind shear and accompanying eddies. The site of the accident is denoted by the "x" within that zone.

Figure 1. The low-level jet stream flow, back-wave vortices were produced over the area of the accident.
