AIRCRAFT ACCIDENT REPORT

MOHAWK AIRLINES, INC.
MARTIN 404, N449A
ROCHESTER-MONROE COUNTY AIRPORT
ROCHESTER, NEW YORK
JULY 2, 1963

ATTACHMENT #1

CRASH KINEMATICS

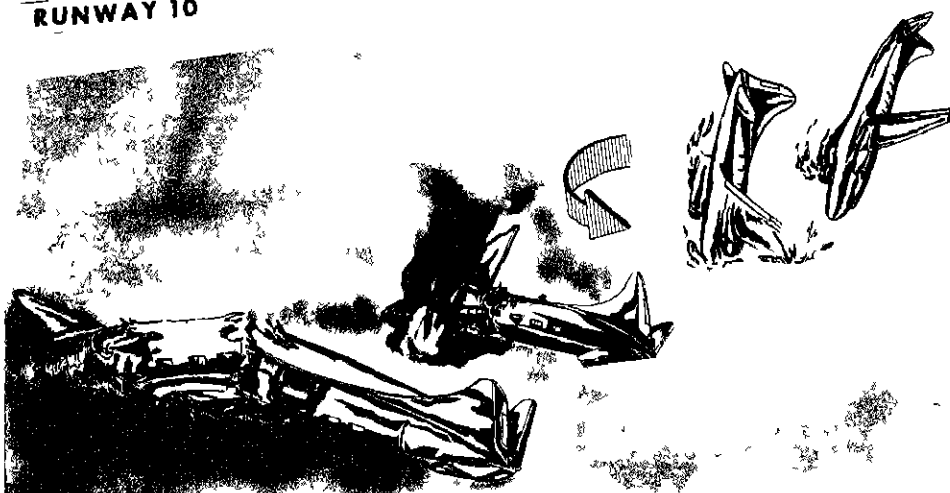
The aircraft contacted the ground 220 feet south of the centerline and 4,668 feet from the threshold of runway 28, and it came to rest 566 feet south of the centerline and 5,022 feet from the threshold of runway 28.

Contact with the ground was first made by the left wing tip. The aircraft then began to disintegrate in a left curving turn (see Attachment 1), cartwheeling, and came to rest on a magnetic heading of 280° in a drainage excavation approximately 6 feet deep adjacent to the takeoff runway. The aft section of the fuselage with empennage attached fractured around the circumference immediately behind the wing rear spar, pivoting approximately 90° coming to a stop in virtually an upright position against the remaining portion of the left wing and engine nacelle. The forward section was reduced to a mass of torn, twisted, and compressed metal. The center section remained intact and attached to the center wing panel, sustaining only interior damage. During and following the principal impact, all 20 double passenger seats were torn free from their attachments. Most seats were thrown free of the wreckage. Both engines were torn free of the aircraft and were relatively intact. The propeller ground slash marks indicated that all propeller blades were intact prior to impact. Test of the propeller governors indicated that the engine RPM at impact were 2760 and 2830 for the left and right engines, respectively. Rated takeoff RPM is 2800. Propeller shim plate impact markings indicated that the left propeller blade angle was 34 degrees, and the right propeller blade angle was 33 degrees. Propeller performance data indicated that at this blade angle and RPM, the left propeller would have been absorbing 2440 BHP at 90 knots, and 2380 BHP at 100 knots. Similarly the right propeller power absorption would have been 2440 and 2360 BHP at these airspeeds, respectively. Wet rated takeoff power for this engine is 2400 BHP. Using left powerplant data as more representative because of impact conditions, the groundspeed at impact was calculated to be 92 knots.
